**LEBANON CONSERVATION COMMISSION**  
**JUNE 8, 2023 - 6:30 PM**  
**COUNCIL CHAMBERS, CITY HALL OR**  
**REMOTE VIA VIRTUAL PLATFORM**  
**LEBANONNH.GOV/LIVE**

**FOREST OBSERVATIONS, DESCRIPTIONS  
AND PRESCRIPTIONS**  
for  
**THE BOSTON LOT and SIGNAL HILL**  
*owned by*  
**The City of Lebanon**  
*located in*  
**Lebanon, Grafton County**  
**New Hampshire**

Hydrogeologic Cross-Section A-A`  
Test Well Sites at Lebanon Water Treatment Facility  
Lebanon, NH

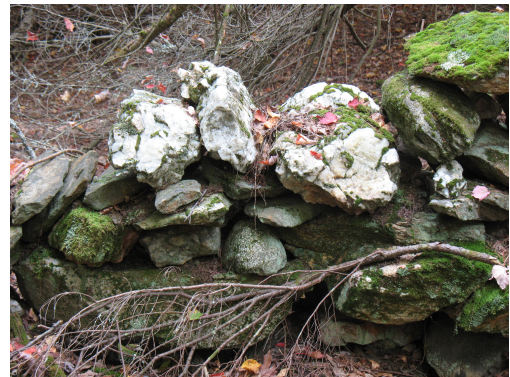
**At Signal Hill quartz is a component of the stone walls.**

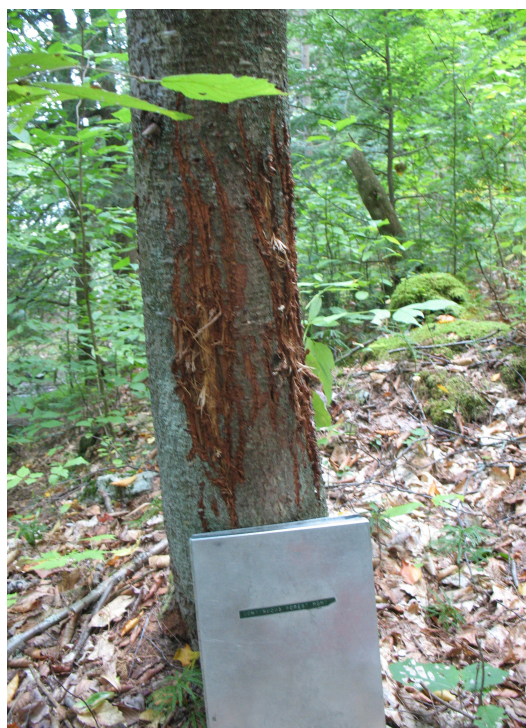
**Bear will scrape trees like this balsam fir to communicate messages such as the bounds of their territory.**

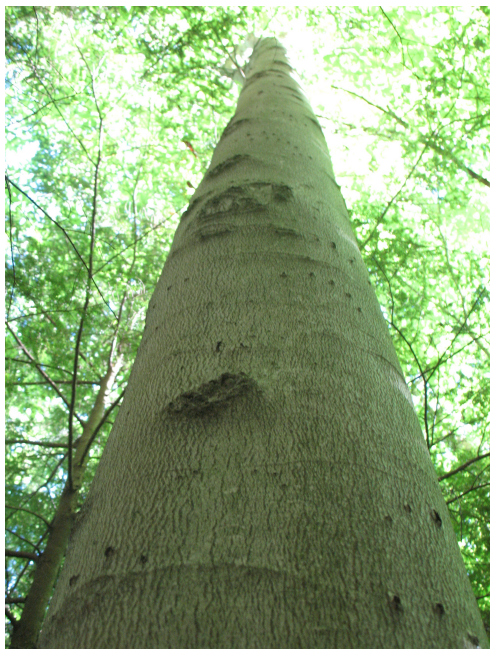
**Bear will climb American beech trees to feast on the protein rich beech nuts. It is important to protect bear trees such as this one, which also appears to be tolerant of Beech Bark Disease.**
